# BELZONA PROTECTS WASTEWATER PUMP FOR 25 YEARS

ID: 5519

Wastewater pump

Wastewater Treatment Plant,  
Vancouver, BC

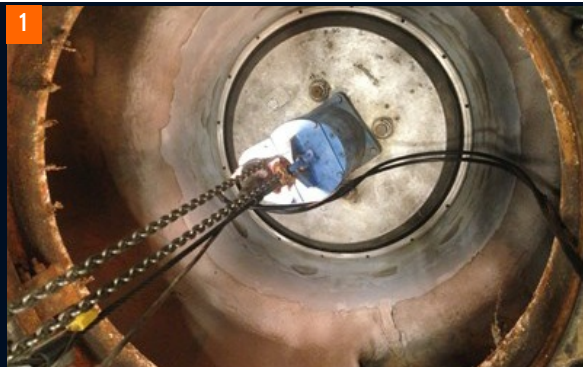
1. The pump bowl after the lower portion had been grit blasted.
2. Rebuilding the lower bowl section with Belzona 1311 in progress.
3. Additional rebuilding underway.
4. The rebuilt areas and the entire lower portion of the bowl received 2 coats of Belzona 1321.

This wastewater pump was originally rebuilt in 1989 with Belzona when the lower portion of the pump bowl had eroded severely causing small pinholes to develop in the side casing.

This pump has remained in constant service since the 1989 repair. It was taken out of service for a major inspection. The inspection revealed that small sections of the original repair were showing signs of delamination along the edges so it was decided that these would be repaired while the pump was down.
