# BELZONA REPAIRS TO HIGH SPEED VESSEL

ID: 552

Corrosion in the joint between the deck and the upper structure of the vessel.

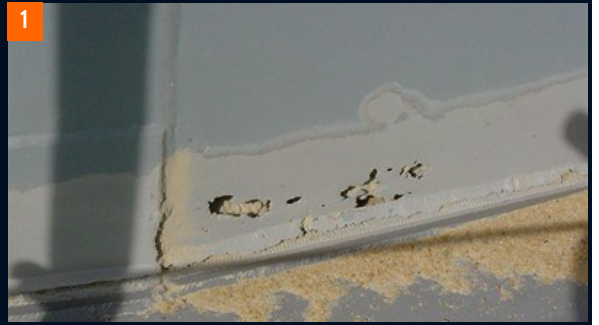
1. The corroded structure of the launch
2. Application of Belzona 2111
3. Belzona 2121 coating was applied to seal the whole area
4. Launch ready for service
