# BELZONA PROTECTS PIPE WITH INTERNAL LINING

ID: 5524

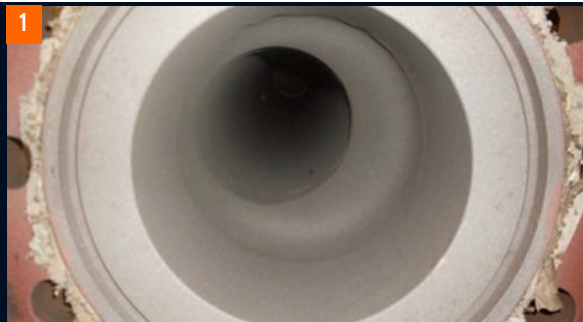
1. Internal surface after blasting.
2. Internal surface of the pipe coated with Belzona 5891.
3. Close-up after the application of Belzona 5891.
4. Overview of the pipelines.

The weld seams and irregularities were roughened by grinding. The internal surface of the pipes was prepared by blast cleaning to a near white metal finish, SSPC SP-10 Sa 2½ standard. After the removal of residue and cleaning with a degreaser, Belzona 1121 was applied to smooth the weld seams/irregularities. Then the 1st layer of Belzona 5891 was applied at a thickness of 300-400 microns. After the initial mechanical stability of Belzona 5891, brush-off blast cleaning was carried out and the 2nd layer of Belzona 5891 was applied at a thickness of 300-400 microns. In the straight sections, the coating of Belzona 5891 was applied. Inspection was carried out and the identified misses were retouched.
