# BELZONA PROTECTS NEW STAINLESS STEEL PIPE SPOOLS

ID: 5526

Gas Fired Power Station, Avonmouth, UK

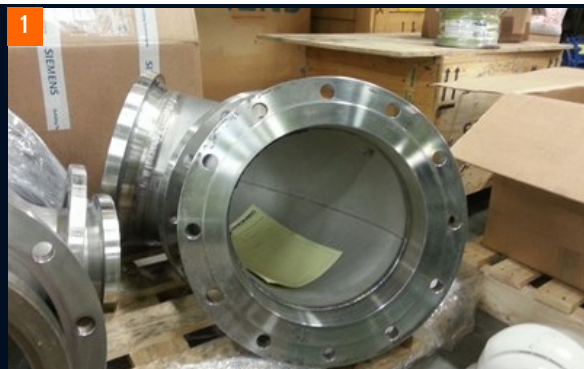
1. New pipe spools before coating
2. New pipe spools before coating
3. Pipe spools after coating
4. Pipe spools after coating

The application was carried out in accordance with Belzona Know-How System Leaflet VPF-2. After masking off all areas not to be coated, all edges were radiused and welds ground smooth before being grit blasted and coated with the Belzona 4311 system.
