# BELZONA PROTECTS TOOTHPASTE FACTORY FLOOR

ID: 5530

Pressure pot room where colour is added to toothpaste

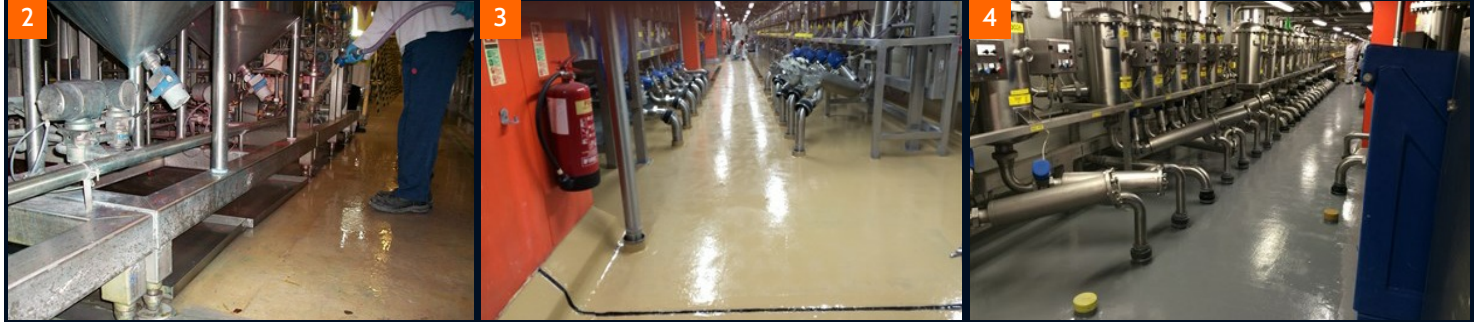
## PHOTOS

The originally applied protective coating on the floor had failed, due to the spillage of Flavour Oils and the use of caustic soda to clean the room daily. As a result, water/cleaning fluid was leaking through the floor and into the packing area below. The existing polyurethane coating was in most part still intact and showed good adhesion to the steel/aluminum chequer plate. The area's which have failed are where the floor is most exposed to the chemicals i.e. drain areas and flow paths. Access to some of the areas was restricted by pipe work and plant.

1. Damaged Floor
2. Washing to remove dye
3. 1st coat application
4. 2nd coat application

The application was carried out in accordance with Belzona Know How System Leaflet FPA-3. All sound areas of the existing coating were left in place as total removal was not an option.

Prior to the application, a trial area of 50m<sup>2</sup> was applied with the Belzona system. Thoroughly satisfied with the result, the customer proceeded with the application to the complete 2000m<sup>2</sup> area.
