# WALL REPAIR OF CYCLONE FEED SUMP WITH BELZONA

ID: 5533

## PROBLEM

Damage on the wall of the cyclone feed sump, due to impact from the fall of ore and balls from mills.

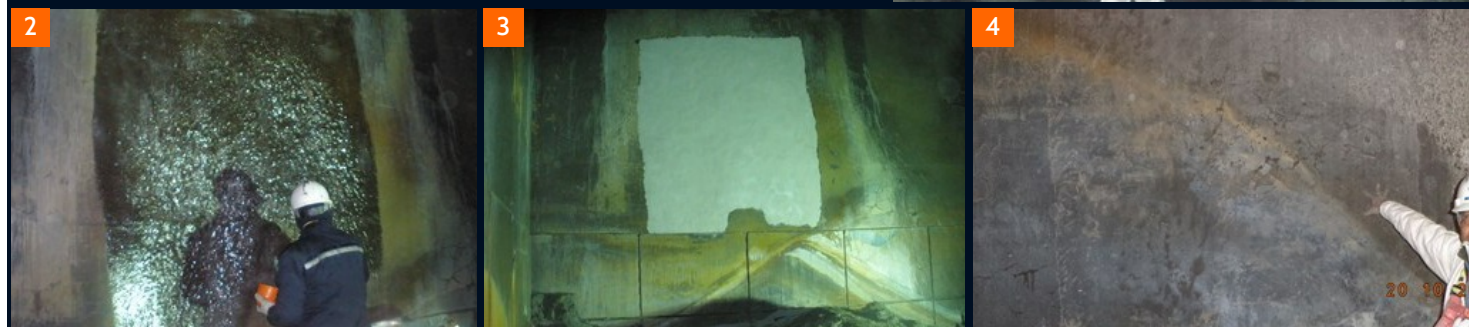
1. Preparation of substrate
2. Application of Belzona 4911
3. Wall repaired with Belzona 4111
4. Inspection on October 20, 2012

The application was carried out in accordance with Belzona Know-How System Leaflet FPA-1. The surface was prepared with a pressure washer and salt removal products. All loose material was removed and later dried with compressed air.

Belzona 4111 provides high adhesion to the old concrete, exceptional resistance to impact, vibration, abrasion and chemical attack. To date the repair has not suffered wear or loss of thickness.
