# BELZONA REPAIRS PILLARS OF A RAILROAD TRACK

ID: 5534

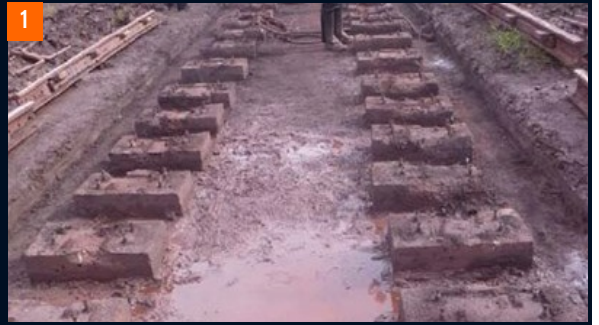
The area of the 48 deteriorated pillars negatively influence the operation of the railway.

1. General view of the damaged pillars
2. Installation of the forms to the pillars after cleaning
3. Application of Belzona 4111
4. Wagons operating on the repaired pillars

The pillars were first cleaned with a water jet and steel brush. The leveling of the pillars was carried out with the assistance of a topography tool and then Belzona 4111 and Belzona 4151 were applied. The application was carried out in accordance with Belzona Know-How System Leaflet TCC-9 and FPA-1.
