# BELZONA PROTECTS NEW BUILD DESALTER

ID: 5540

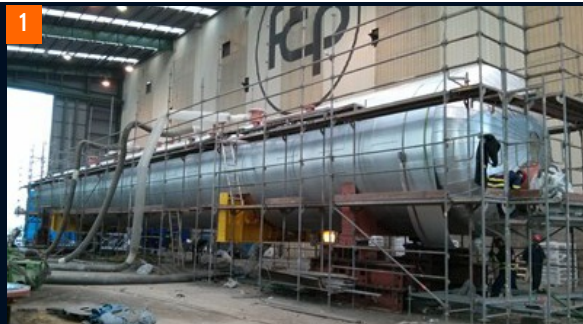
1. Desalter
2. Substrate fully grit blasted.
3. Finished application.
4. Remedials in November 2020 with Belzona 1593.
