# BELZONA REPAIRS LOOSE WEAR RING

ID: 555

Wear ring in main cooling water pump

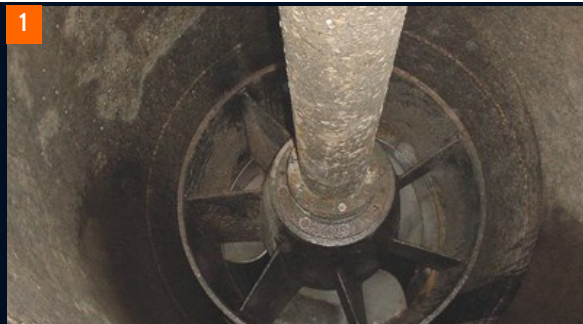
1. General view of the pump
2. Corrosion caused wear at the ring
3. Application of the first layer of Belzona 1321
4. Removing excess material after injecting the second layer of Belzona 1321

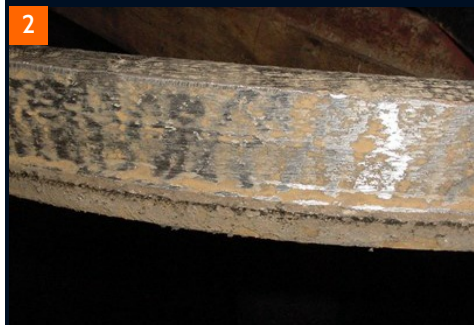
Ring had become loose in its housing.
