# BELZONA REPAIRS AND PROTECTS CONCRETE CHANNEL

ID: 5550

Feeding channel of the concrete box.

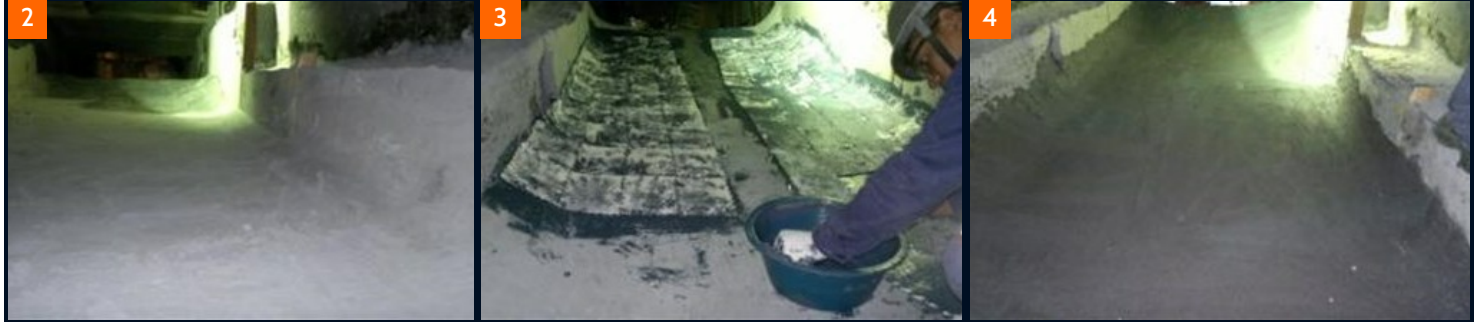
## PHOTOS

The channel presented widespread wear on the surface due to abrasion caused by the flow of copper ore.

1. Wear on the concrete channel.
2. Channel repaired with Belzona 4111.
3. Application of Belzona 9811.
4. Service completed with the application of Belzona 1812 over Belzona 9811.

The channel was cleaned in order to remove the copper ore residue. After being dried, the surface was conditioned with Belzona 4911. Wooden structures were installed to recover the walls of the channel. The worn areas were filled with Belzona 4111. Next, they were coated with Belzona 1321, Belzona 9811 and Belzona 1812.
