# BELZONA PROVIDES LONG TERM PROTECTION FOR ION EXCHANGE VESSEL

ID: 5552

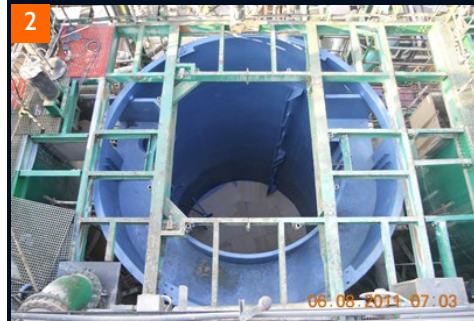
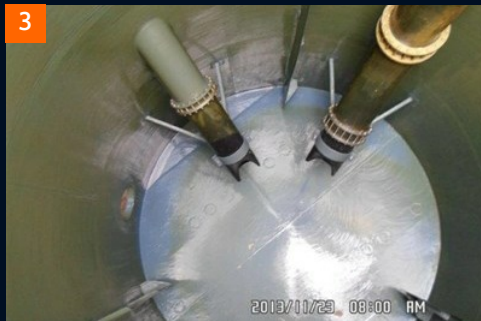
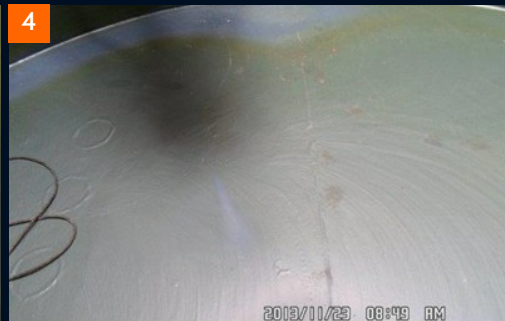
1. External view of Resin in Pulp tank.
2. Completed application of Belzona 1321 in 2011.
3. Inspection in 2013. Lining has stained from the process but is in perfect condition.
4. Close view of the base of the tank where the most wear occurs. Lining in excellent condition.

The customer decided in 2011 to replace the failing glassflake lining entirely with Belzona 1321. The application was carried out in accordance with Belzona Know-How System Leaflet TCC-3. Following surface preparation to the required standards, all internal surfaces were lined with three coats of Belzona 1321 for additional erosion protection. Following lining, the application was thoroughly inspected prior to return to service.
