# BELZONA GRIP SYSTEM FOR ELECTRIC DRIVE ROLLER

ID: 5555

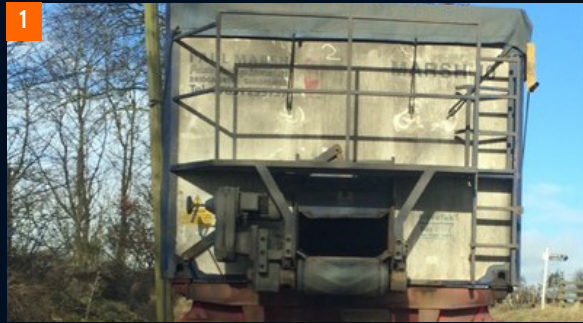
The rubber cladding on the exterior of the drive roller had failed and delaminated.

1. Drive roller on lorry
2. Drive roller prepared
3. Application of Belzona 1321
4. Completed application of grip system
