# BELZONA IMPROVES SAFETY AT SHOPPING CENTER

ID: 5556

Council Owned Shopping Center, UK

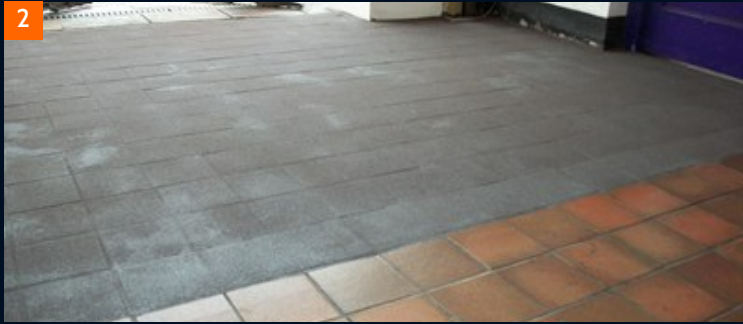
2

1. Hazardous area at the entrance to the shopping center
2. Slip reduction system introduced in 2011
3. System still in place in 2015

The application was carried out in accordance with Belzona Know-How System Leaflet FPA-8. After repairing broken tiles with Belzona 4111, Belzona 5811 was applied thinly as a two coat system before Belzona 9231 was sprinkled onto the surface to give the desired level of grip.

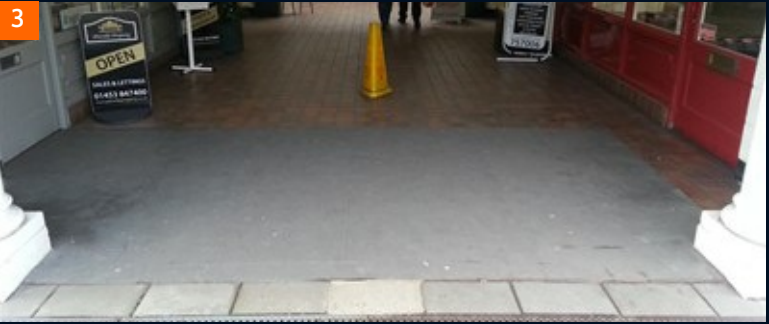
3

The application was completed in 2 stages to allow the shopping center to continue to trade with minimum disruption. It was also carried out through the cold winter period. The system was revisited in February 2015 and it is still exhibiting excellent slip resistance. Thousands of people have been walking over it and the council has not had one slip, trip or fall reported in four years!
