# BELZONA UPGRADES SAFETY OF STAIRS AT MULTI-STORY CAR PARK

ID: 5558

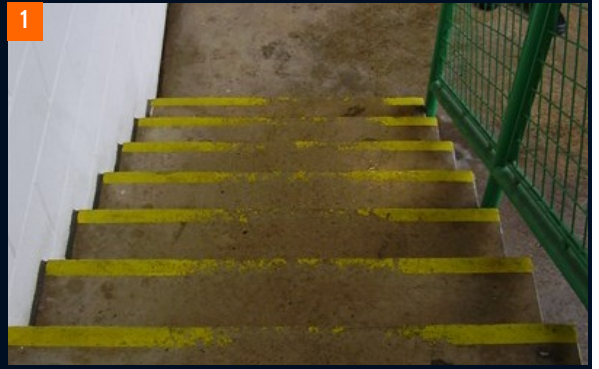
Steps presented a slip hazard to users of the car park.

Worn steps.

1. Original painted grip system
2. Belzona 4411 grip system applied in 2008
3. Application revisited in 2015

The application was carried out in accordance with Belzona Know-How System Leaflet FPA-8. Belzona 9221 was encapsulated in Belzona 4411 and applied in an even coat.

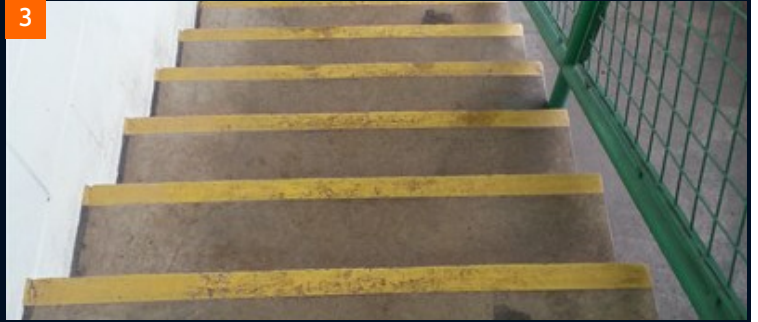
These stairs have been used by thousands of people over the last 7 years and they were shutting down these stairs every couple of months to re-paint prior to the Belzona 4411 application.
