# BELZONA REPAIRS JACK HAMMER BASE IN PRIMARY CRUSHER

ID: 5559

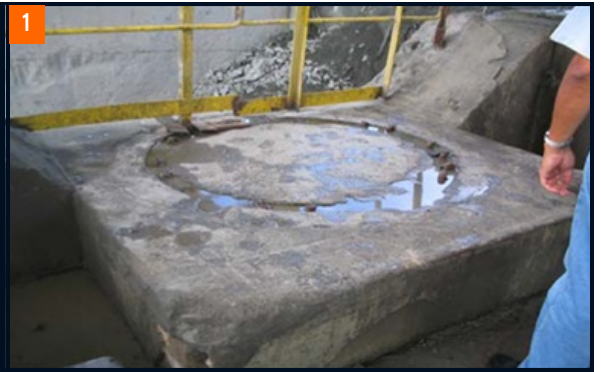
The bolts at the base of the jack hammer suffered from shear stress resulting in loosening of the base and possible fall from the equipment inside the hopper of the primary crusher.

1. Concrete base with the cut bolts
2. Conditioning of the concrete base with Belzona 4911
3. Application of Belzona 4111 and Belzona 4151 at the installation of the bolts in the holes
4. Repair of the base, completed

Some holes were made with a diamond-tipped bit to a depth of 1,250 mm to install new bolts. The concrete base and the open holes were cleaned with soap and water to eliminate any residual oil or grease. The area was adequately dried and cleaned. Later Belzona 4911 was applied at the base of the concrete as well as in the open holes. The base was leveled with Belzona 4111, leaving an opening of 0.5 cm between the block and the base. After grit blasting the metal to a near white finish, the surface was cleaned and conditioned, the base of the jackhammer and the bolts were installed over the base. Belzona 4111 and Belzona 4151 were applied in the housing of the bolt and were injected between the concrete base and the other metallic base of the jack hammer.
