# BELZONA PROPELLER REPAIR - TUGBOAT

ID: 556

Voith Schneider® Propellers on a large tugboat.

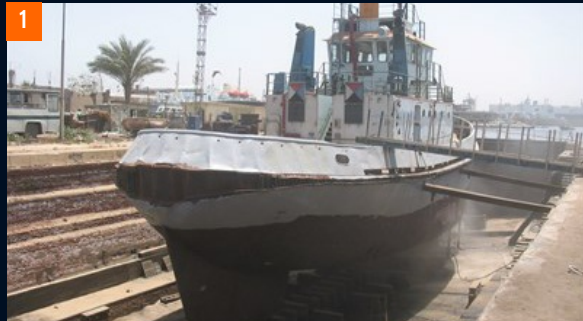
1. General view of the tugboat
2. Erosion-corrosion evident
3. Surface after blasting
4. Application of Belzona to protect the propellers
