# BELZONA CORROSION PROTECTION FOR SUCTION SCRUBBER

ID: 5563

Internal corrosion protection of process vessels and utility tanks was required. LP suction scrubber presented in this case study.

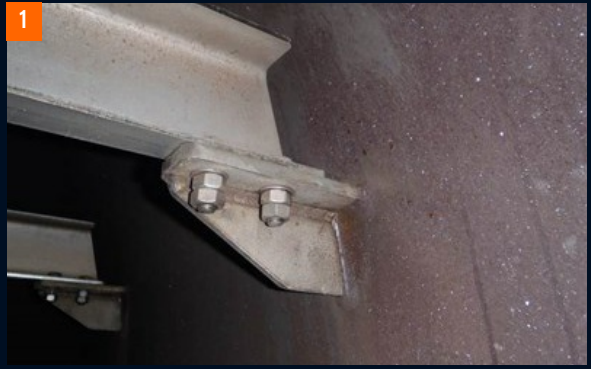
Belzona lining was specified to protect new process vessels and utility tanks. Based on Belzona track record since the 1990s, the customer opted for a carbon steel shell lined with Belzona rather than stainless steel cladding. During the 2013 inspection, it was reported that the Belzona lining was in excellent condition. Local repairs carried out during the initial application were still in very good condition with no sign of degradation.

1. Inspection in 2013 - Inside view of the scrubber
2. Patch repair
3. Different view of patch repair
4. View around ladder
