# BELZONA REPAIRS FILTER PLATES IN MINING INDUSTRY

ID: 5568

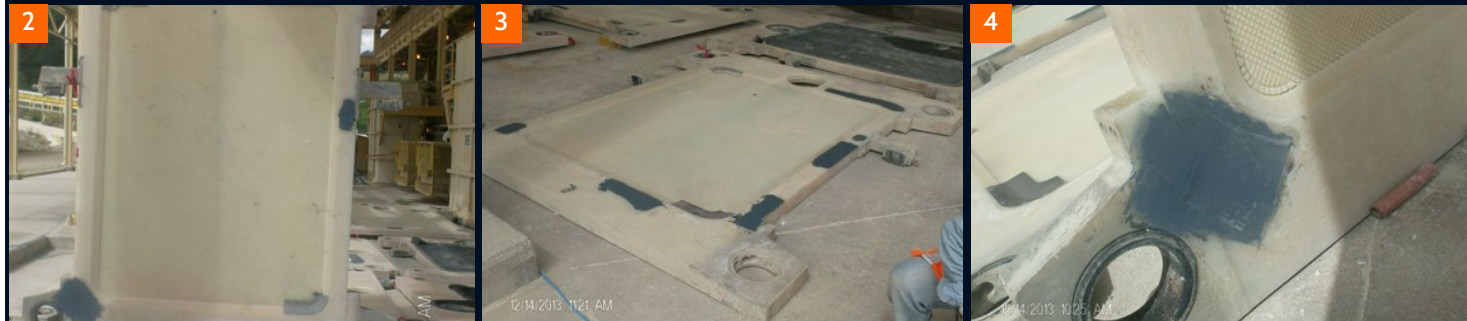
## PHOTOS

Due to the stress and abrasive wear these plates are subject to, they exhibit damages, such as grooves and cracks, that can cause a shutdown of the unit, and as a result, a shutdown of operations.

1. View of the size of the filter and its 86 plates installed
2. Completed plate application ready to be installed back into the filter
3. Completed plate application ready to be installed back into the filter
4. Close up view of the application of Belzona 1311 and Belzona 1321

The application was carried out in accordance with a modified Belzona Know-How System Leaflet VPF-8. The plates were manually repaired with Belzona 1311 and Belzona 1321 in the damaged areas.
