# FIRST STAGE SEPARATOR: SEVEN YEARS OF PROBLEM- FREE SERVICE FROM BELZONA 1591

ID: 557

New process package for the Janice oil field comprising test and first stage separators.

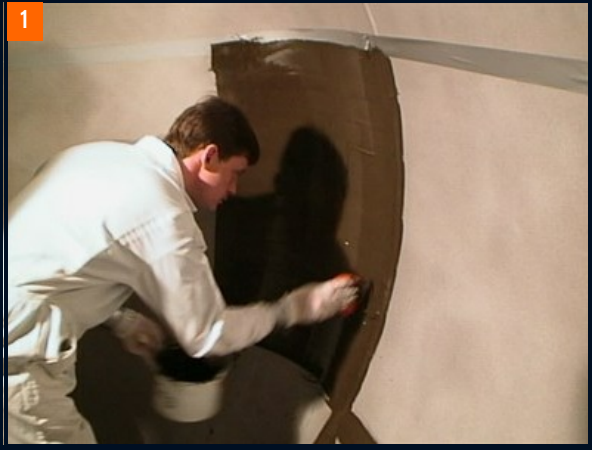
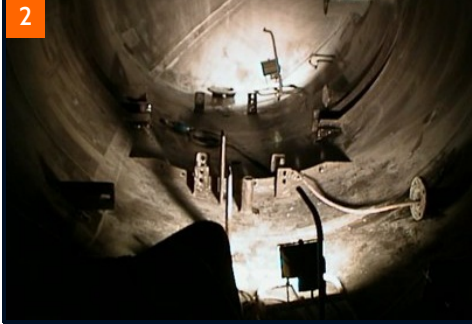
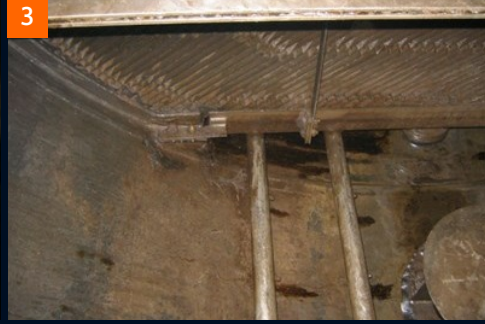
1. & 2. & 3. Vessel being coated in 1998.
4. Vessel opened in 2005.

Application was carried out in accordance with Belzona Know-How System Leaflet TCC-5.

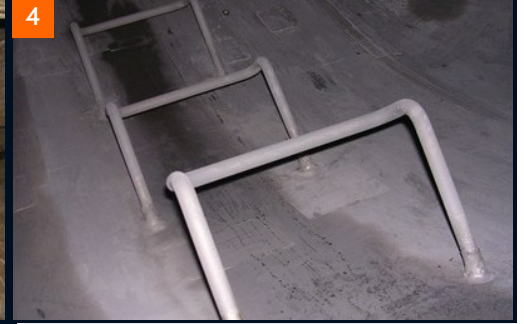
The use of a high temperature erosion-corrosion resistant coating allows separators and other vessels to be fabricated more cost effectively out of Carbon Steel rather than Stainless or Duplex Steel. After seven years of service, the Belzona® 1591 was found to be in excellent condition.
