# BELZONA SUPERWRAP II RESTORES PIPE AT DAM WALL

ID: 5572

A 30 inch diameter stub pipe protruding from a dam wall.

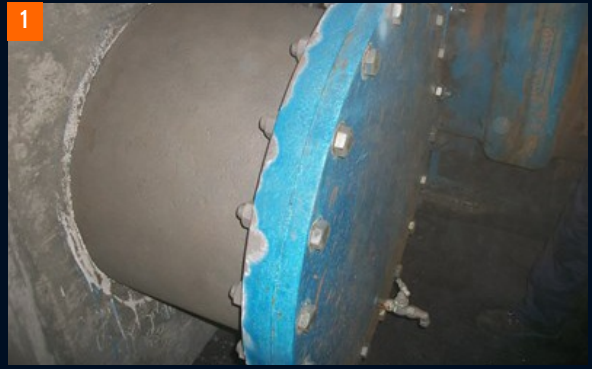
The pipe had suffered from corrosion over time which had caused the formation of pits on the surface of the steel. This resulted in weakening of the pipe wall and requirement to repair the steel. As the pipe cannot be shut off, an in-situ, cold applied repair was chosen.

1. Pipe condition following grit blasting
2. Initial wrap commencing
3. Following complete system application, Belzona 9382 release film is applied
4. Completed application with release film removed

The application was carried out as per the Belzona Superwrap II method statement provided. Following thorough grit blasting to the required standard, the Belzona Superwrap II system was applied. Once the required thickness and number of wraps were achieved, the repair was consolidated in Belzona 9382 Release Film and allowed to cure. Once cured the Belzona 9382 release Film was removed.
