# BELZONA SUPERWRAP II PATCHES SEAWATER BULK MEDIA FILTER VESSEL

ID: 5574

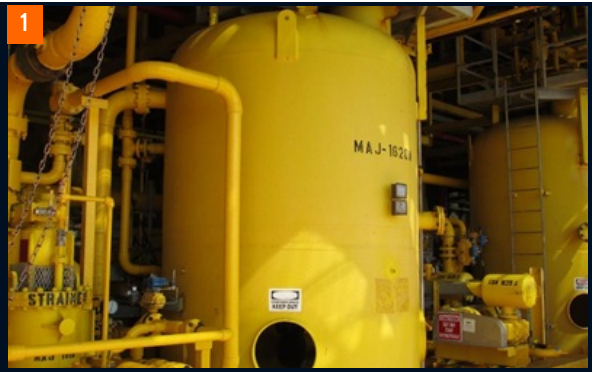
Damage to the external part of the bottom of the vessel due to corrosive environment and seawater transported in the vessel.

1. Seawater Bulk Media Filter Vessel
2. After abrasive blasting
3. Belzona 1212 used to patch over thin wall area and sealed through-wall defect
4. Belzona Superwrap II applied as per engineered design
