# BELZONA REBUILD AND PROTECTS TURBINE RUNNER

ID: 5579

Hydropower Plant, British Columbia, CA

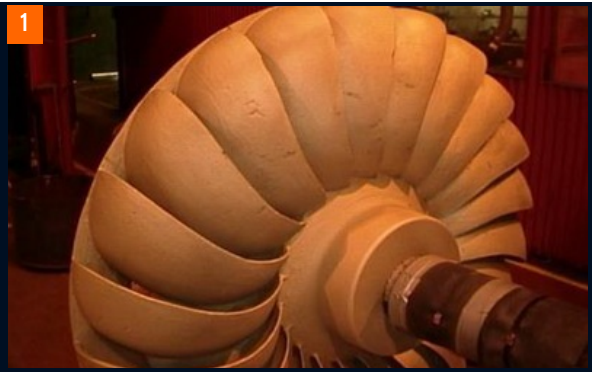
The Turbine Runner was showing signs of erosion on the leading edges of the vanes

1. Turbine Runner after initial grit blasting
2. Leading edges of vanes rebuilt with Belzona 1311
3. Application of the 1st coat of Belzona 1341 in progress
4. Completed application of the 2nd coat of Belzona 1341

The surface was properly prepared and the application was carried out in accordance with Belzona Know-How System Leaflets CEP-1 and CEP-3.
