# BELZONA REPAIRS A LARGE HYDRAULIC RAM

Eight meter hydraulic ram of a transport winch

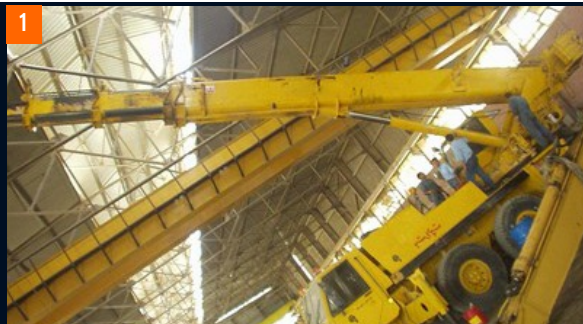
1. General view of the hydraulic ram
2. Scores on the ram
3. The ram after repair
4. Finishing the surface then cleaning it

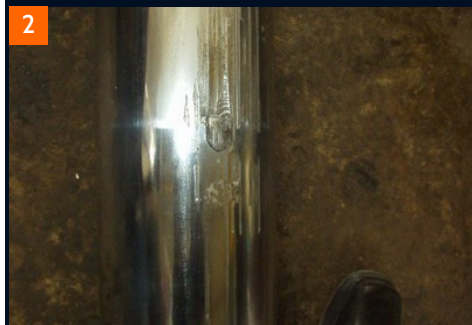
Deep and wide scores in many areas of the ram.

There were scores in many areas of the ram causing many leakages and fluid losses. Belzona saved the replacement costs of the ram, returning it successfully to service.
