# BELZONA AIDS SEALING OF VJ COUPLINGS

12" crude oil pipeline on FPSO

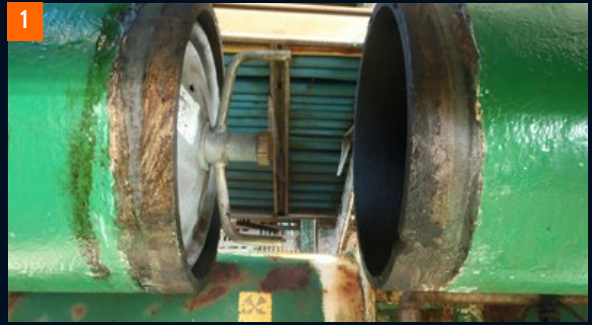
Corrosion on pipeline prevented VJ coupling from sealing correctly.

1. Corroded pipe ends
2. After grit blasting the corrosion pitting clearly evident
3. Former in place
4. Coupling re-installed on smooth Belzona formed pipe ends
