# BELZONA REPAIRS OFFLOADING HOSE ABOVE WATER

ID: 5585

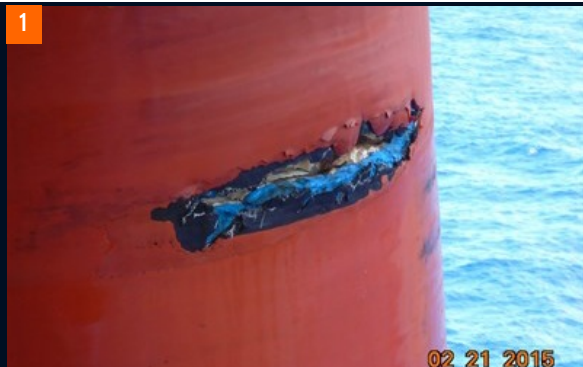
During the normal operation of transfer, staff noticed a small tear in the rubber hose. Three weeks later, the tear had tripled in size and this is when the crew called the experts.

1. View of damaged hose
2. Surface preparation
3. Completed application
4. Overview of the application

The application was carried out in accordance with Belzona Know-How System Leaflet SOS-12. The surface was roughened before the application of Belzona 2911 followed by the reinforced system of Belzona 2211 to the damaged areas.
