# BELZONA KEEPS WATER OUT AND THE ENVIRONMENT SAFE

ID: 5586

Off loading hose damage.

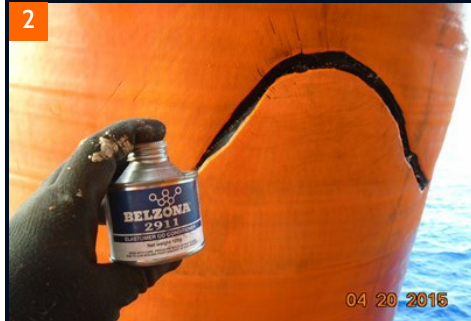
The crew noticed a tear in the rubber of the off loading hose and took the quick decision to call in the experts to repair it with Belzona.

1. Damaged area
2. Belzona 2911
3. Reinforcement sheet
4. Completed application

The application was carried out in accordance with Belzona Know-How System Leaflet SOS-12. The surface was roughened before the application of Belzona 2911, followed by the reinforced system of Belzona 2211 to the damaged areas.
