# BELZONA REPAIRS CUI ON A TRANE CHILLER

ID: 5588

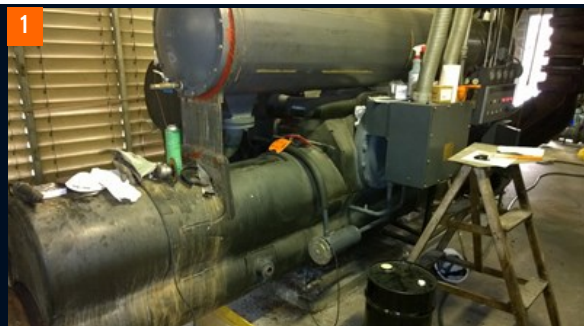
1. The application area after the insulation has been removed.
2. The corrosion was concentrated along a linear trough formed by the rubber insulation.
3. The shell fared back out with Belzona 1212.
4. The finished repair ready for insulation.

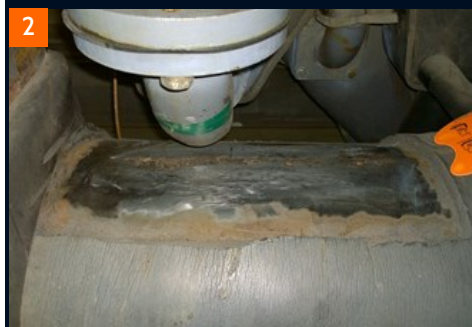
0.2 inch (5 mm) deep corrosion under insulation threatened to perforate the shell of this chiller. Condensation was traveling through an ineffective seam and pooling in a trough between two sections of foam insulation. This section of the shell experienced almost continual immersion and the attendant corrosion rates.
