# BELZONA 3411 SOLVES CORROSION PROBLEM FOR NATURAL GAS

ID: 5589

A Flange (DN100) on the pipework of a purification unit handling triethylene glycol.

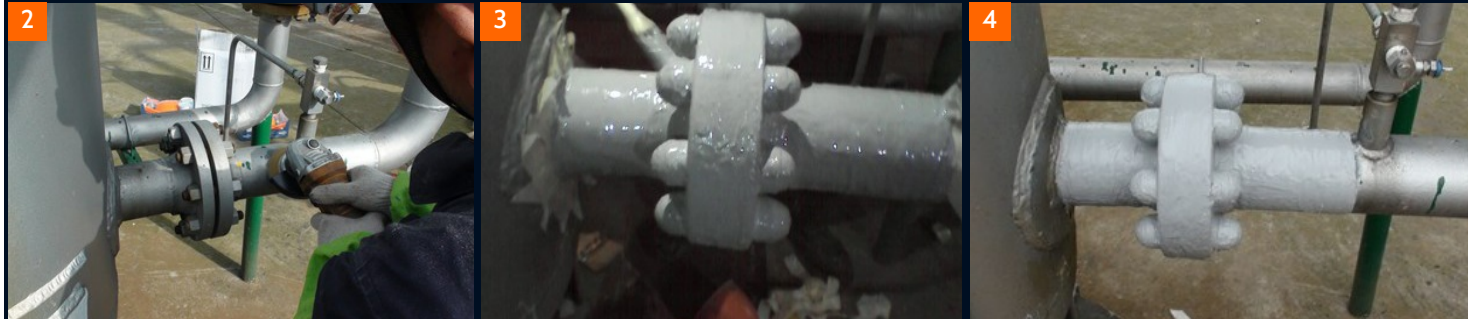
Corrosion around the flanged connections, bolts and welding area.

1. Corroded flange
2. Surface preparation
3. Application of Belzona 3411 by brush
4. Completed application

The application was carried out in accordance with Belzona Know-How System Leaflet GSS-11.

The Belzona 3411 encapsulating system provides a complete corrosion protection for flanges, fastenings and associated pipes. It is also as a preventive system which helps improving and facilitating further monitoring and inspection due to the peelable and re-sealable properties. The customer is very satisfied with this innovative solution.
