# BELZONA REPAIRS PVC PUMP

ID: 559

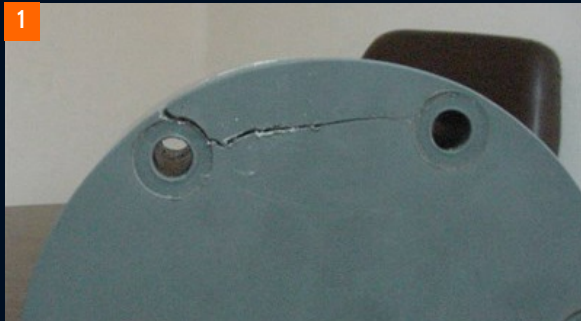
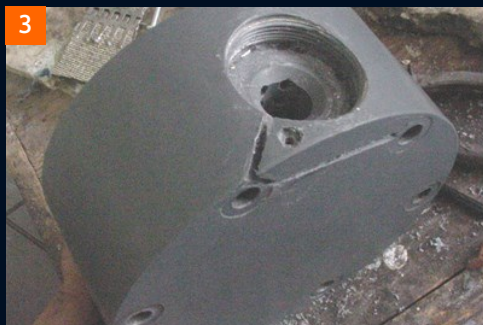
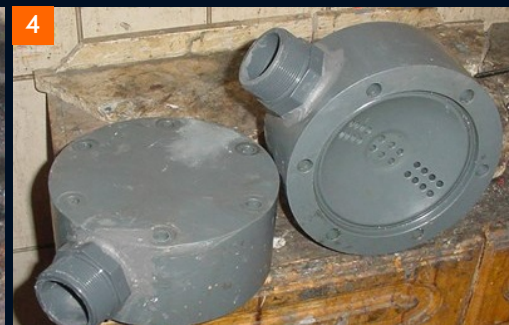
Cracked casing

1. The crack in the PVC pump
2. Stabilising the crack
3. Cracks after preparation
4. Cracks repaired

Application was carried out in accordance with a modified version of Belzona Know-How System leaflet CEP-6. The cracks were stabilized by drilling and widening it then filled with Belzona® 1111.
