# BELZONA ELASTOMER SEALS A TRANSFORMER'S BUSHING

ID: 5597

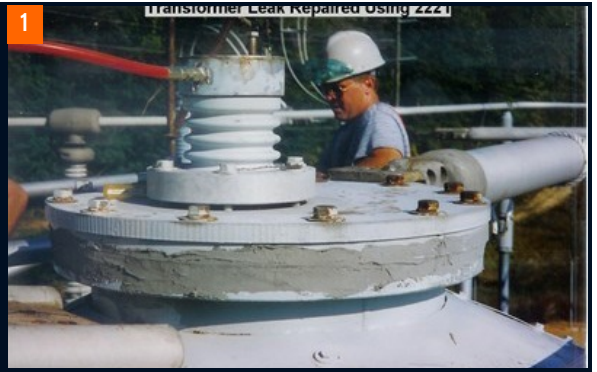
1. View of the transformer
2. Belzona 2221 poured into a fabricated mold
3. Bushing completely sealed with Belzona 2221
