# BELZONA SEALS OIL AND GAS LEAK IN A TRANSFORMER

ID: 5598

Transformer bushing

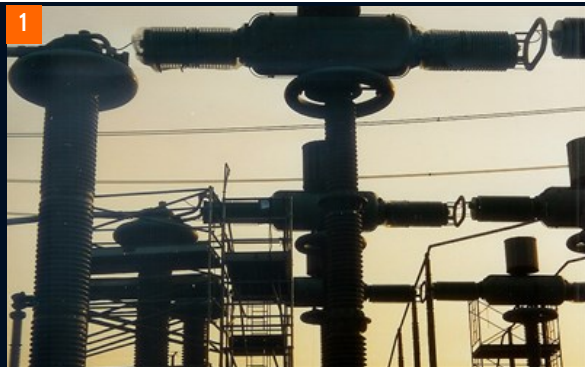
The bushing was leaking oil and gas, creating an environmental hazard and affecting the proper operation of the transformer.

1. Substation overview
2. Application under progress
3. Sealed area
4. Completed application

The application was carried out in accordance with a modified version of Belzona Know-How System Leaflet VPF-11. The area was properly prepared and sealed with Belzona 2111 and coated with Belzona 2121.
