# BELZONA REPAIRS TURBINE WICKET GATES

ID: 5599

Wicket gates

Hydropower Plant, USA

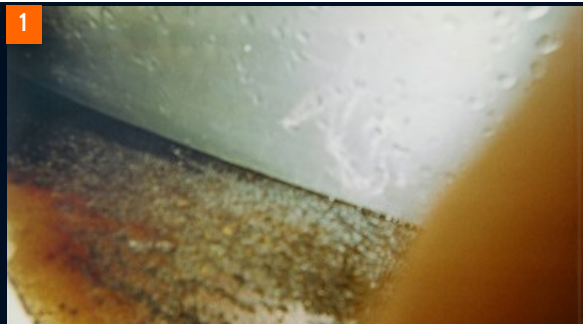
The wicket gates were suffering from cavitation damage due to the water flow. This unit has 1,000,000 gallons of water per minute running through it.

1. Cavitation damage to the wicket gate
2. Close up of the repaired area with no more cavitation
3. Completed application

The application was carried out in accordance with a modified version of Belzona Know-How System Leaflet CEP-5.

Belzona 1221 (Super E-Metal)  
Belzona 1341 (Supermetalgilde)
