# BELZONA REPAIRS TRANSFORMER COOLER

ID: 5601

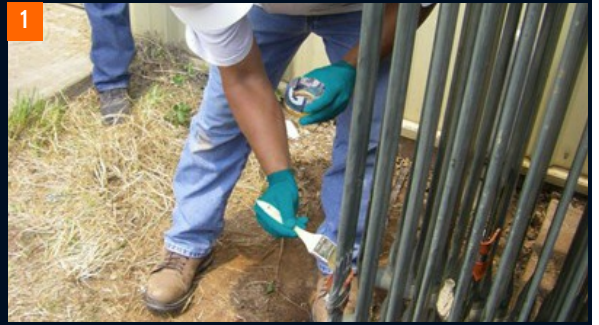
1. Preparing the surface
2. Belzona 2121 (red) applied over the reinforcement tape
3. Finalizing the repair with Belzona 2121 (black)

The application was carried out in accordance with a modified version of Belzona Know-How System Leaflet VPF-11. The leaks were repaired with Belzona 2121 and reinforcement tape, similar to a pipe repair.
