# BELZONA SEALS SPIRIT BUND

ID: 5602

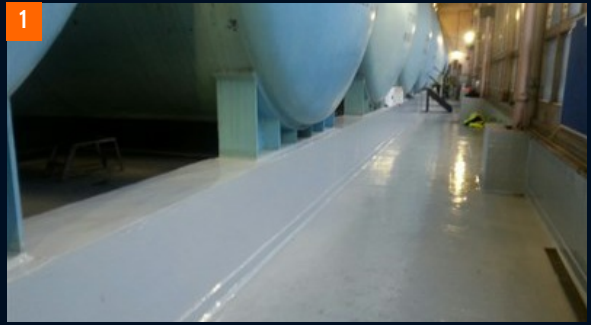
1. One of the Vat plinths
2. Belzona 4131 fillets around the plinth
3. Completed application with Belzona 5811 to seal the area

The application was carried out in accordance with Belzona Know-How System Leaflet TCC-15. The floor was prepared with grinders before Belzona 4131 and Belzona 4141 were used to repair defective areas. Fillets were created with Belzona 4131 at all corners around the bund. Finally, two coats of Belzona 5811 were applied to completely seal the area.
