# BELZONA RAM REPAIR = BIG SAVINGS

ID: 5603

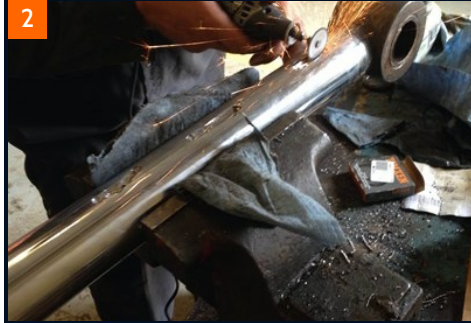
Damaged ram was allowing hydraulic fluid to leak.

Hydraulic ram suffering scars in 3 places from being repeatedly struck against the side of a dumpster. Customer was looking for an alternative to replacing the expensive ram.

1. Damage to the ram
2. Cleaning up the edges with a Dremel
3. Belzona 1111 post application/waiting to cure
4. Completed application to ram and ready for service

The application was carried out in accordance with Belzona Know-How System Leaflet MPT-3. We used a handheld drill and drill press to square the corners and a die grinder and dremel tool to clean up the edges. A propane torch was used to sweat out residual oil both before and after drilling and grinding. Brake cleaner was used for a final cleanup before application.
