# UPGRADED BELZONA LINING SPECIFICATION FOR SEA WATER PUMP

ID: 5604

Sea Water Cooling Pump

Power Plant, Taiwan

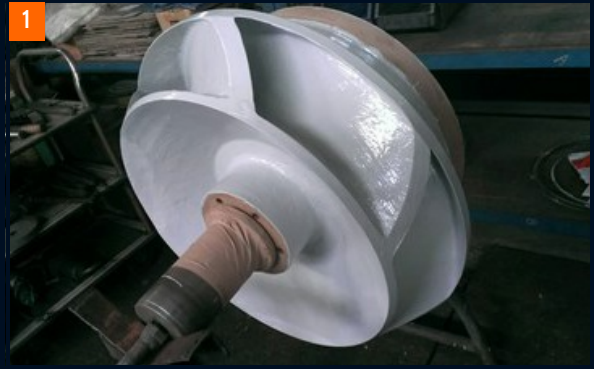
1. Completed application on impeller
2. Completed application on casing
3. Completed application on casing
4. View of completed application on cooling water pump
