# BELZONA KEEPS RIG RUNNING AFTER GLASS FLAKE FAILURE

ID: 5606

A 52" diameter seawater discharge caisson made up of 5 sections of varying lengths (between 11 and 15 meters) on an offshore oil rig required internal corrosion protection.

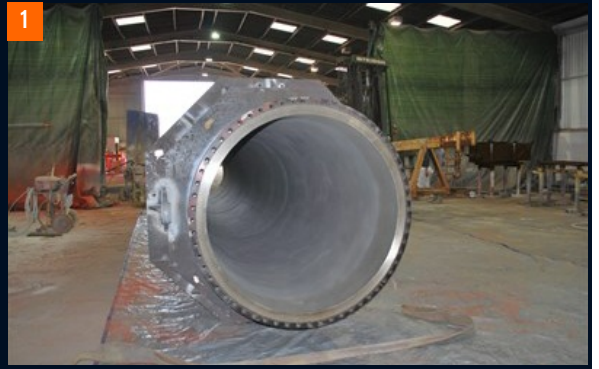
1. Grit blasted caisson
2. Spray application in progress
3. Lining thickness being measured
4. Completed application

The application was carried out in accordance with Belzona Know-How System Leaflet VPF-2. The coating was applied at a thickness of 2 x 1000 microns to optimize longevity of the equipment. Flange faces were protected with Belzona 1111.
