# VALVE REPAIR AND PROTECTION WITH BELZONA

ID: 561

Automatic chemicals valve.

Power plant, Egypt

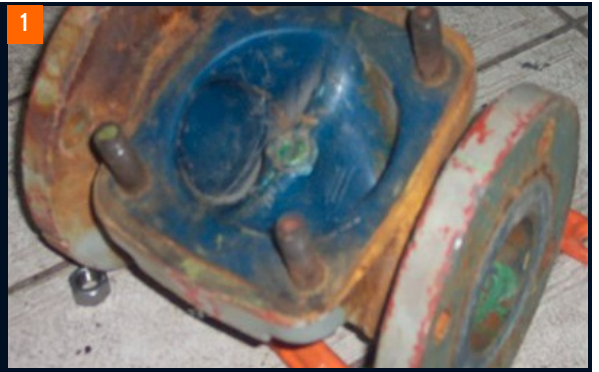
Old polypropylene lining was worn and damaged due to chemical attack.

1. The valve before repair
2. Former made by casting with Belzona 5811
3. Belzona 1311 applied to the valve
4. Two valves were repaired and protected

Application was carried out in accordance with modified version of Belzona Know-How system leaflet VPF-1 and VPF-2. A former was made by casting Belzona® 5811 to take the inner shape of the valve. The eroded areas were then rebuilt with Belzona 1311, using the Belzona® 5811 former to restore the inner curvature profile of the valve. After finishing the surface it was coated with Belzona® 1321 to protect the valve.
