# BELZONA REPAIRS A LEAK ON A CATION TANK

ID: 5614

Outlet from demineralization tank.

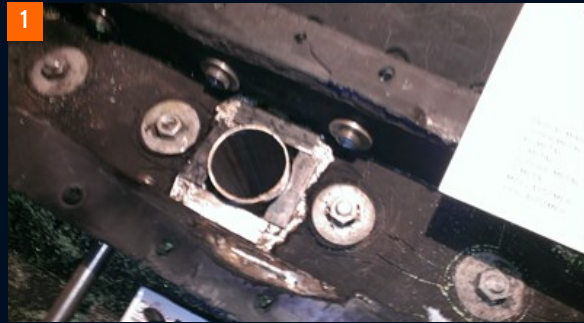
Leaking outlet from the demineralization tank. Both metal repairs and rubber lining restoration were necessary.

1. Cation tank outlet repair using doublers
2. Doubler plates bonded using Belzona 1221 and Belzona 9341
3. Belzona 2111 applied over the rebuilt area to restore the rubber lining

The application was carried out in accordance with a modified version of Belzona Know-How System Leaflet ENC-10. Doubler plates were bonded around the new pipe penetration with Belzona 1221. Belzona 9341 was used to span corner openings and wrap to new outlet piping. All the contact surfaces were prepared with an angle grinder. Belzona 2111 was applied directly over the bonded plate repair to restore the rubber lining.
