# BELZONA REPAIRS AND PROTECTS TURBINE ROTOR

ID: 5615

Wear caused by the effects of erosion and cavitation to the rotor with a waterfall height of 110 meters.

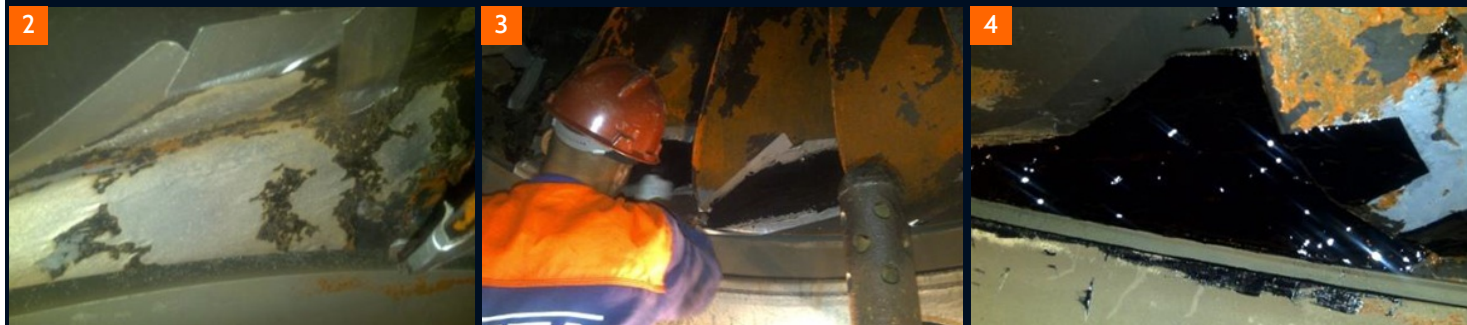
1. Worn area of the rotor
2. Defining the application area
3. Application under progress
4. Completed application

The application was carried out in accordance with Belzona Know-How System Leaflet CEP-1. The surface was prepared according to the standard NACE 2 (equivalent to SA 2 ½) with dry abrasive blast to near white metal. Belzona 1311 was applied to smooth the wear on the vanes (holes and loss of thickness) and then, Belzona 2141 was partially applied in certain areas of the rotor. Subsequently, Belzona 2141 was applied in 2 coats.
