# BELZONA SEALS LEAK IN BUTTERFLY VALVE

ID: 5617

Butterfly valve.

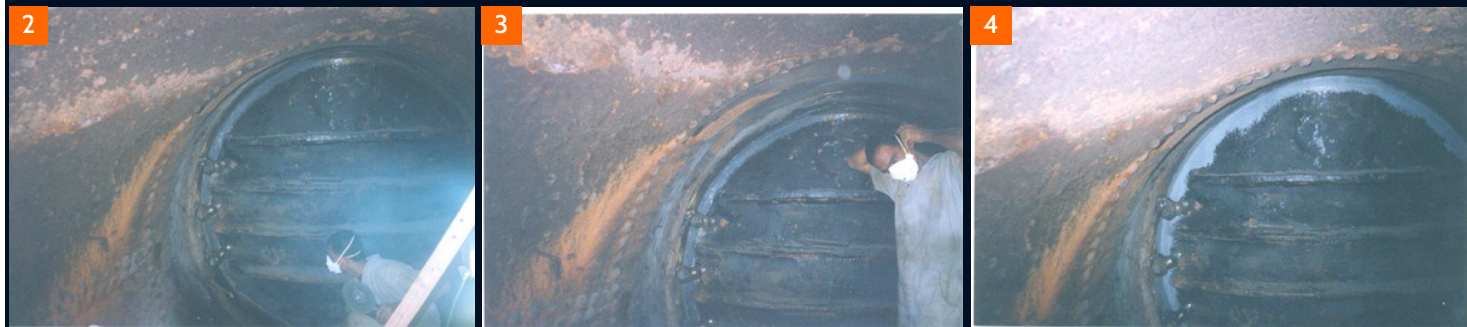
The valve presented excessive leaking, compromising the seal of the fluid and the interior of the pipe.

1. Cleaning the surface
2. Application of Belzona 1221 to the leak area
3. Application of Belzona 1111 in progress
4. Completed application

First, the water flow was diverted to allow the application. The application was carried out in accordance with Belzona Know-How System Leaflet VPF-1. The surface was prepared with a grinder, emery cloth and wire brush. The valve was locked and Belzona 1221 was applied to stop the leak. After Belzona 1221 cured, Belzona 1111 was applied.
