# BELZONA REPAIRS AND COATS HYDROELECTRIC TURBINE PIPELINES AND VANES

ID: 5618

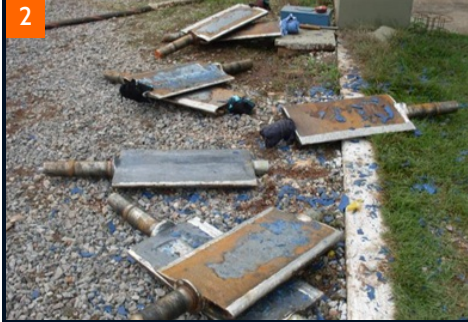
Wear caused by erosion and corrosion in the areas with high water turbulence.

1. Internal surface of the damaged pipeline
2. Damaged vanes
3. Lower area of the pipeline coated with Belzona 1321
4. Vanes protected with Belzona 1321

The application was carried out in accordance with Belzona Know-How System Leaflet CEP-1. The surface was prepared with a dry abrasive blast and cleaned with a degreaser. The worn areas were repaired with Belzona 1311 and then coated with Belzona 1321 to protect against erosion and corrosion.
