# BELZONA RECOVERS AND COATS ELECTRIC ENERGY POLE

ID: 5619

Pole that supports lines with electric energy transmission.

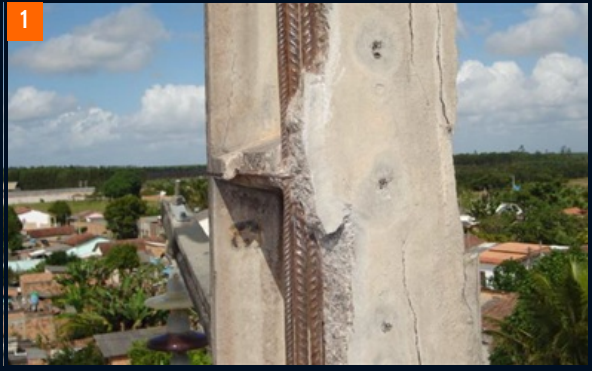
Wear to the poles generated by environmental corrosion and/or excessive compression of the maintenance equipment necessary to raise them.

1. Pole with damages
2. Surface preparation
3. Completed application
