# BELZONA RECOVERS ELECTRIC ENERGY TRANSMISSION TOWER BASE

ID: 5620

Concrete base of the leg of the transmission tower.

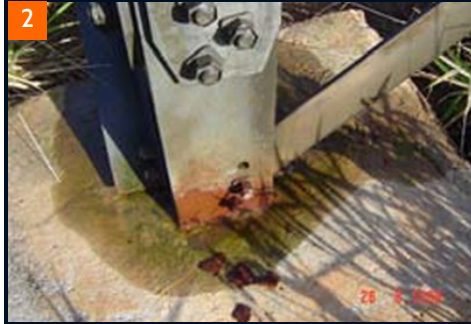
1. View of the transmission tower
2. Deteriorated base
3. Application of Belzona 4111
4. Waterproofed base with Belzona 3111

The application was carried out in accordance with Belzona Know-How System Leaflet GSS-3. Firstly, the concrete surface was abraded, cleaned and allowed to dry. The conditioner, Belzona 4911, was applied and allowed to dry. Belzona 4111 was then applied. After the completed cure time and dry to the touch of Belzona 4111, Belzona 3921 was applied and after the specific amount of time, Belzona 3111 was applied.

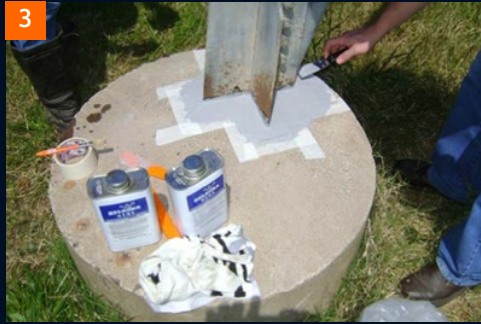
Due to the transmission towers being exposed to weathering, its concrete bases suffer from deterioration. The accumulated rainwater tends to oxidize the structure of the tower, weakening the metal base.
