# BELZONA SAVES THE CARBON FIBER

ID: 5621

30' long carbon fiber shield on a paper mill.

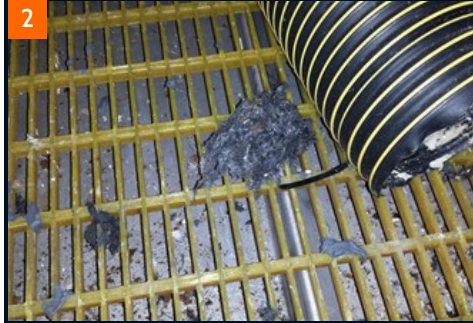
The customer uses a pressure washer to clean off the fiber carbon shield, resulting in the carbon fiber deteriorating and pieces of it falling off.

1. Damaged carbon fiber shield.
2. Pieces of carbon fiber falling off.
3. Application of Belzona 1311.
4. Completed application.

The surface of the application area was cleaned with a pressure washer, prepped with wire brushes and then blown off with air to remove the loose fiber particles. Belzona 1311 was then applied with Belzona applicators and putty knives at 1/4" thick.
