# BELZONA SEALS TRANSFORMER OIL STORAGE TANKS

ID: 5622

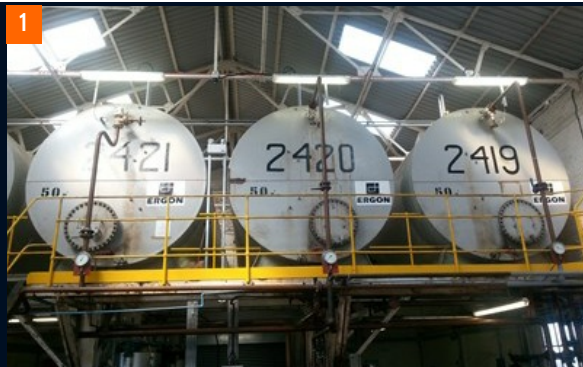
Transformer oil storage tanks. The client recycles millions of liters of transformer oil every year. As part of the process, they extract the moisture from recycled oil by shutting the tanks off from the atmosphere and connecting the tanks to silica gel tanks to remove the moisture.

1. Transformer oil storage tanks
2. Leaking weld
3. Completed application with protective coating on top
4. Additional repair area

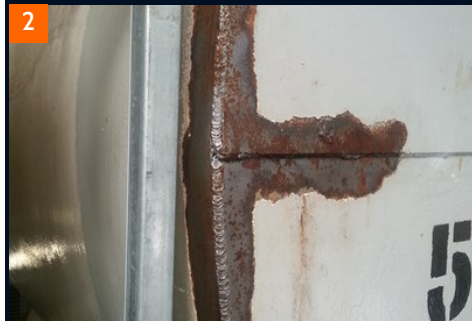
On inspection of the tanks, leaks were evident at the seams. Welding was considered for the repairs, however, due to the area being classed as a confined space and the requirement to take the tanks offline, this was not a desirable option.

The application was carried out in accordance with Belzona Know-How System Leaflet TCC-1. After the initial surface preparation, Belzona 1212 was used to bond pre-manufactured plates onto the damaged areas of the tanks. Once cured, Belzona 5831 was applied to the plated area to provide long term environmental protection. This application was completed on 6 areas where leaks were identified.
