# BELZONA PLATE BONDING REPAIRS TO REACTION TANK

ID: 5624

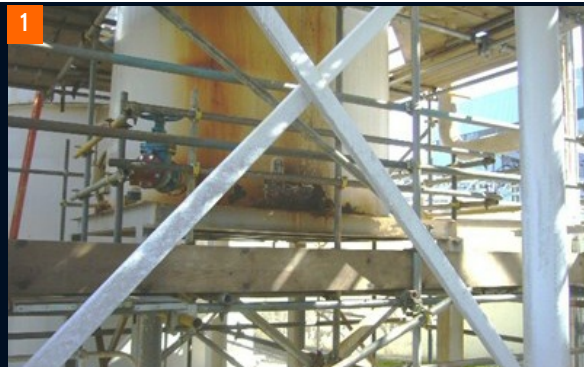
Tank experiencing external corrosion due to rainwater sitting around the lower edges of the outer wall. The external paint system had failed and the tank was going thin wall in places.

1. Tank with scaffold erected
2. Thin wall area
3. & 4. Plate bonded and overcoated
