# BELZONA REPAIRS RUBBER PRESS ROLL

ID: 5636

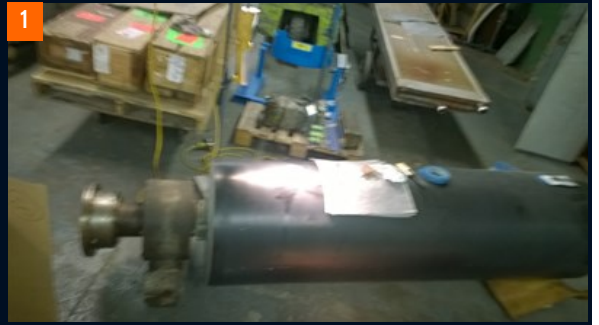
1. Rubber press roll
2. Deep hole in press roll
3. Cleaned, prepped and masked off hole to be repaired
4. Repaired hole and used a razor blade to cut and smooth final surface

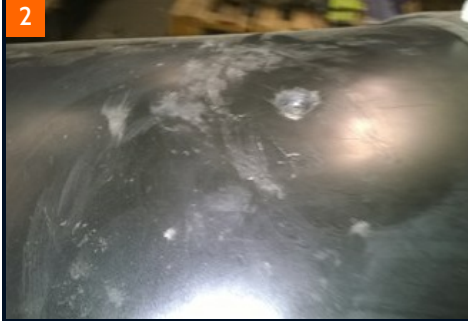
Rubber press roll had a hole caused by a tool impact, which made the roll unusable and not being able to create a smooth gasket.
