# BELZONA REPAIRS WIRE DRAWING MACHINE

ID: 5637

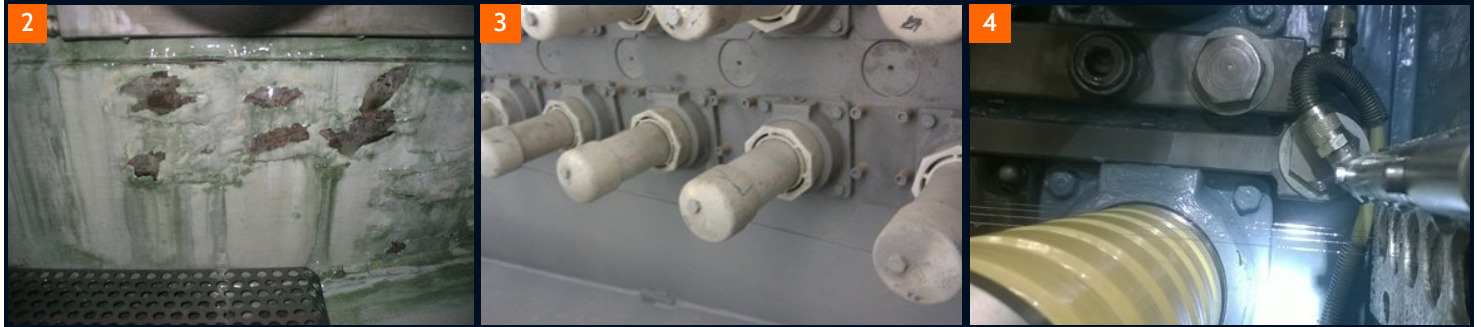
Corrosion cells in the drawing machine interfere with proper gaging and wire conductivity which can ruin an entire run of a specialty cable, in addition, affect plant production and cause quality problems with the finished product.

Cells in the copper wire drawing machine. Customer manufactures woven copper wire assemblies from very small gage communication wire to large gage under sea cable. Thick gage raw copper is drawn in multiple gangs (up to 36 in number) through a wire drawing machine to the desired gage and then twisted and insulated.

1. Overview of the wire drawing machine
2. Corrosion cells in the sump of the drawing machine
3. Blast cleaned surface before coating
4. Close up of coated surface after 2 years of operation, still perfect!

The substrate was cleaned by blasting to a near white finish standard SSPC-10. After surface preparation, Belzona 1341 was properly hand applied in accordance with the relevant IFU.
