# BELZONA SAVES A CRUSHED CRUSHER

ID: 5638

Hard Rock Mine concrete crusher base.

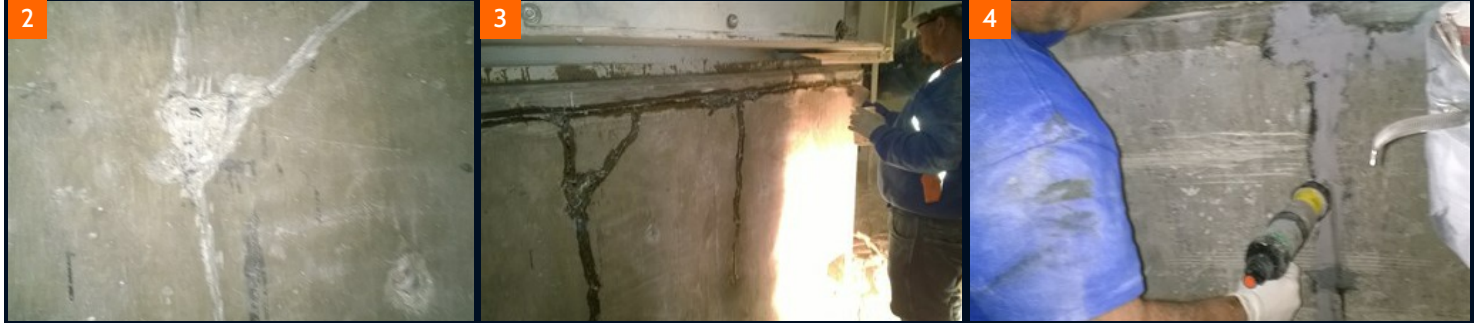
The concrete crusher pedestal developed cracks and caused excessive vibration during crusher operations, leading to premature bearing failure and production to slow down.

1. Crusher overview
2. Series of cracks in foundation
3. Prepped, conditioned and injection screws ready to be overcoated with Belzona 4111
4. Injecting Belzona 4151

Cracks were vee'd out by hand, drilled with injection holes, prepped and faired out with Belzona 4911 and Belzona 4111. Upon initial cure of Belzona 4111, Belzona 4151 resins were injected through the prepared ports under high pressure to chase and fill the underlying voids and cracks. Belzona 1221 was used to seal the injection holes.
